TECHNICAL NOTE

Filing Code 1525 (P-401)
Date Issued December 1969

Bureau of Land Management U.S. DEPARTMENT OF THE INTERIOR

FORD TRUCKS

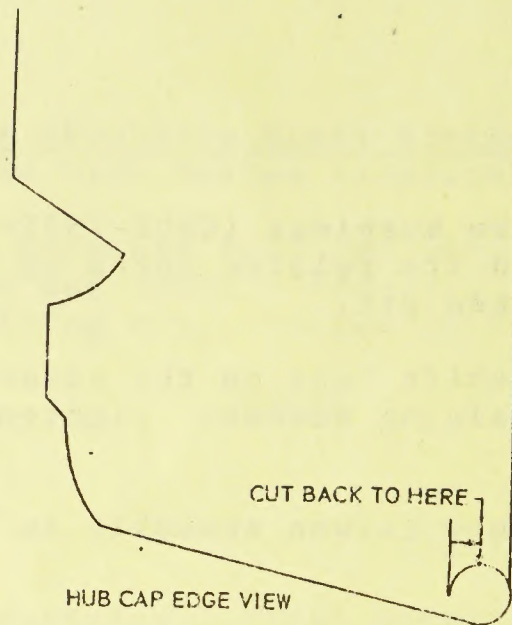
Figure 1

VI. Hub Cap Retention. (F&P250/350-1968-69)

To improve retention remove hub caps and grind the rolled inner edge of the cap at two opposite spots to match the two retaining bosses on the wheel. Remove metal from the inner rolled edge to a point approximately one-third of the total edge. Refer to Figure 1.

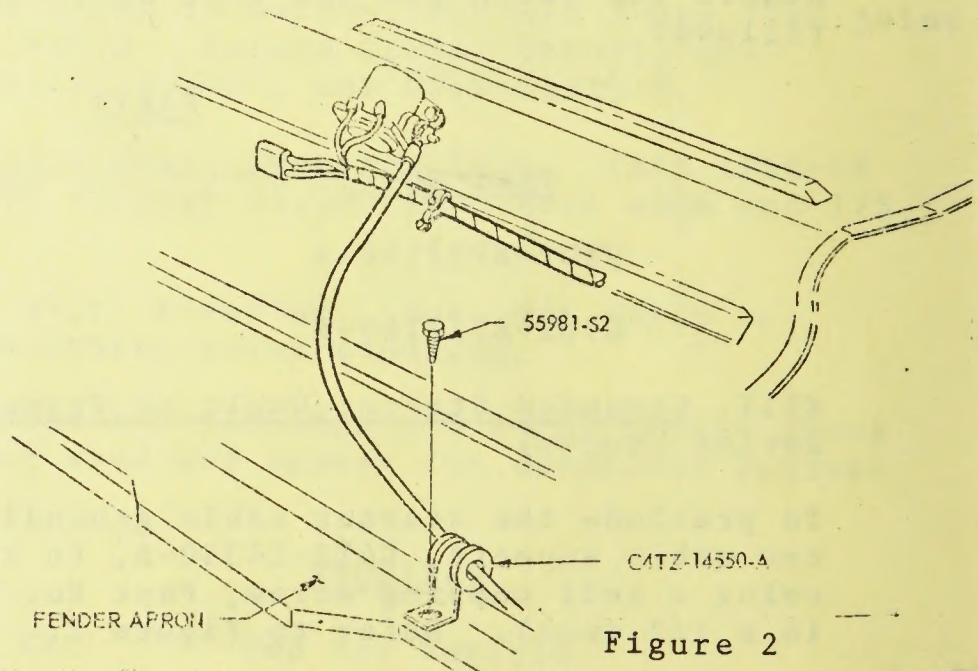
Figure 2

XIII. Grounded Starter Cable to Frame. (1968 - 69 F&B 500-750 Series Trucks)

To preclude the starter cable grounding on the frame, mount a new cable support, C4TZ-14550-A, to the right hand fender apron using a self tapping screw, Part No. 55981-S2 (1/4 inch - 14 x 1/2 inch). Refer to Figure 2.
